Intel® Pentium® III Processor Specification Update

Release Date: April 2002

Order Number: 244453-040

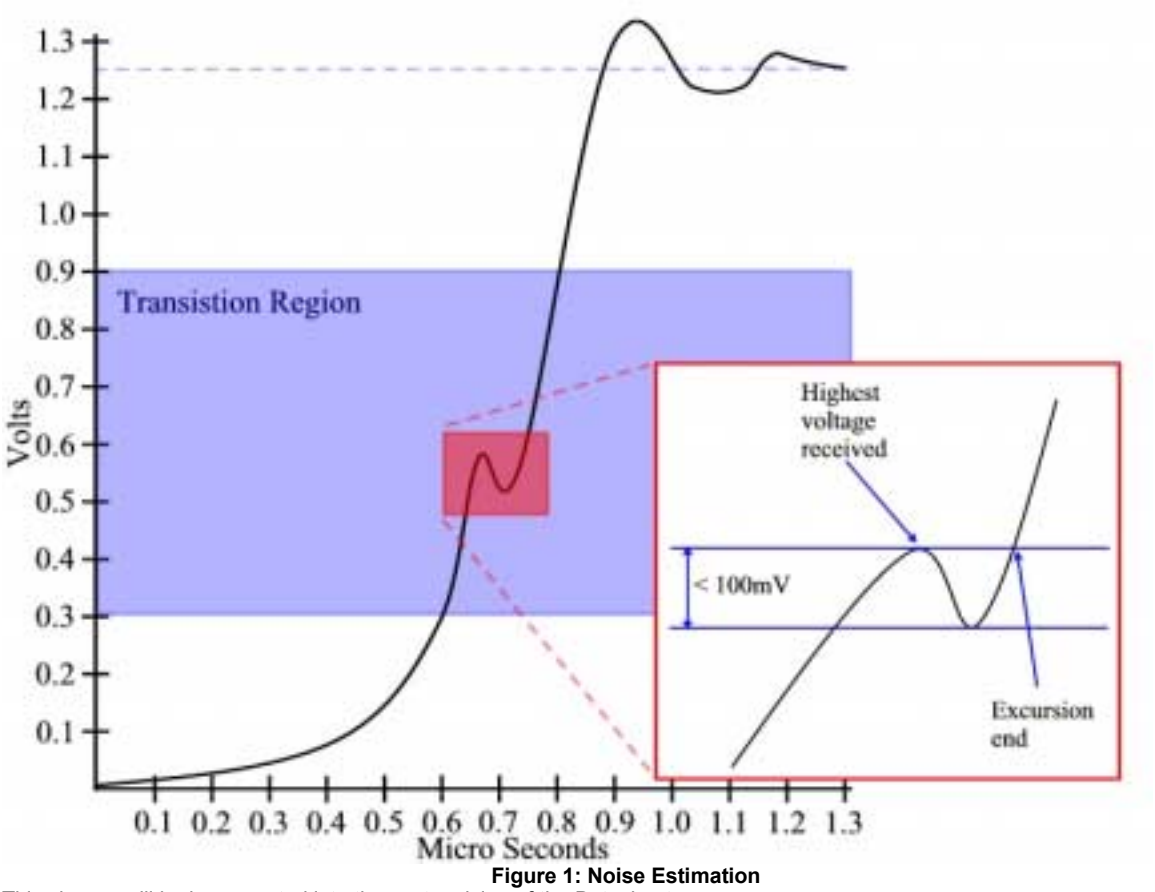
Figure 1: Noise Estimation

The signal quality of the VTT_PWRGD signal is critical to the correct operation of the processor. Every effort should be made to ensure this signal is monotonic in the transition region. If noise or glitches are present on this signal, it must be kept to less than 100mV of a voltage drop from the highest voltage level received to that point. This glitch must remain less than 100mV until the excursion ends by the voltage returning to the highest voltage previously received. Please see Figure 1 for an example graph of this situation and requirements.
